Army Lodging Wellness Recommendation

Final Submittal - Fort Hunter Liggett

February 27, 2004

Fort Hunter Liggett

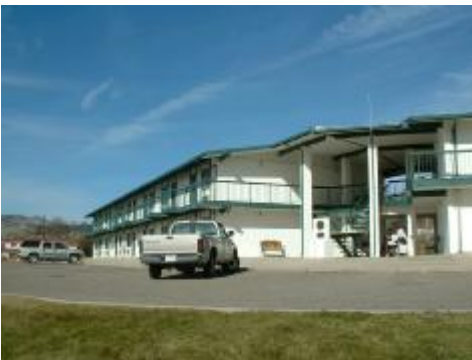
Building 128

Building 128, constructed in 1969, is the main Lodging facility for the installation. This building includes 4 family suites and 46 extended stay rooms. The front desk and administrative functions are currently housed in a separate, shared facility on the installation. Although this building facility was renovated within the last 5 years, it does not meet Lodging standards for a main Lodging facility and cannot be reconfigured without significant reconstruction. Although the cost to make condition assessment improvements is just over 50% of the replacement cost, it is our recommendation to remove this facility from the lodging inventory due to the age of the building, building systems, and additional cost that would be required to add support spaces to meet Army Lodging standards.

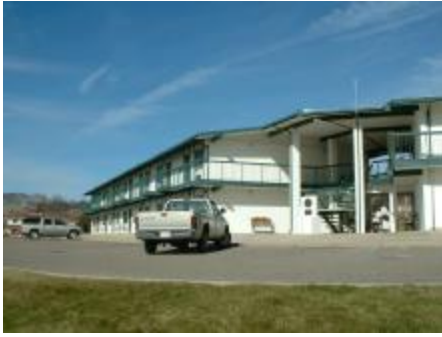
*Building 128, Gibb Hall
128 Infantry Road
Fort Hunter Liggett, California*

Building 128, constructed in 1969, is the main Lodging facility for the installation. This building includes 4 family suites and 46 extended stay rooms. The front desk and administrative functions are currently housed in a separate, shared facility on the installation. Although this building facility was renovated within the last 5 years, it does not meet Lodging standards for a main Lodging facility and cannot be reconfigured without significant reconstruction. Although the cost to make condition assessment improvements is just over 50% of the replacement cost, it is our recommendation to remove this facility from the lodging inventory due to the age of the building, building systems, and additional cost that would be required to add support spaces to meet Army Lodging standards.

Because the Condition Assessment to Replacement Cost Ratio is greater than 50.00%, repair of Building 128 is not recommended.

Our recommendation is to remove building 128 from the Lodging inventory, allowing the installation to determine an alternate use for this facility. This facility will be removed from the Hunter Liggett Wellness Solution and Lodging Master Plan.

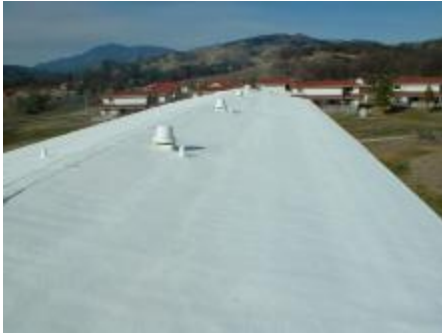
Building 128
Roof

- Analysis: The roofing is a spray polyurethane foam insulation and white elastomeric finish coating with aluminum gutters and downspouts, replaced in 2003 and in like new condition.
- Recommendation: No corrective action required.

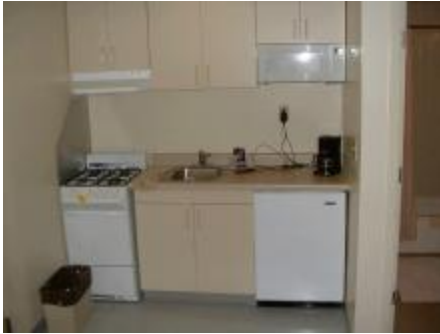
Building 128
Typical Standard Room Kitchenette

- Analysis: The guest room baths have American Standard floor mounted tank water closet, integral bowl counter lavatories and porcelain steel tubs, estimated in the early 1980s, in fair condition. There is a single compartment stainless sink at the kitchenette.
- Recommendation: Replace all guest room plumbing fixtures. Replace the kitchenette sinks in 38 of the 50 rooms.

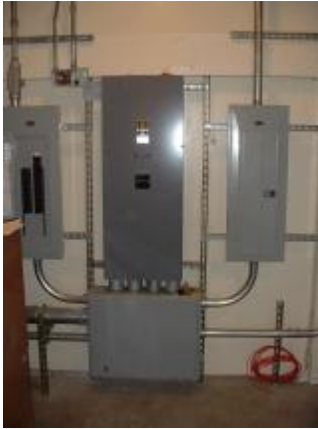
Building 128
New Electrical Service
120/208 volts, 800 amps, 2003

- Analysis: The electrical service is served from a utility pad mount transformer supplying 120/208 volt power to an interior Square D distribution panelboard with an 800 amp main breaker. The new service, completed in 2003 and in like new condition, backfeeds the old original service panelboard, a Delta with a 300 amp main breaker. The new 800 amp service was installed to serve the new HVAC system. The lighting in the guest rooms consists of a 2x4 box surface ceiling fluorescent unit, a surface drum unit at the kitchenette and dressing type incandescent four lamp strip at the bath lavatory plus bedside table lamps.
- Recommendation: No corrective action required to the electrical distribution system except to replace to old original service panelboard. Replace lighting in the guest rooms, common and back of house areas.
